DS2155 T1/E1/J1 Single-Chip Transceiver

REVISION A3 ERRATA

This errata sheet only applies to DS2155 revision A3 components. Revision A3 components are branded on the top side of the package with a six-digit code of the form yywwA3, where yy and ww are two-digit numbers representing the year and work-week of manufacture, respectively. The die revision can also be determined through the lower four bits of the IDR register at location 0Fh. Revision A3 devices contain a B0h at location 0Fh. To obtain an errata sheet on another DS2155 die revision, visit the website at www.maxim-ic.com.

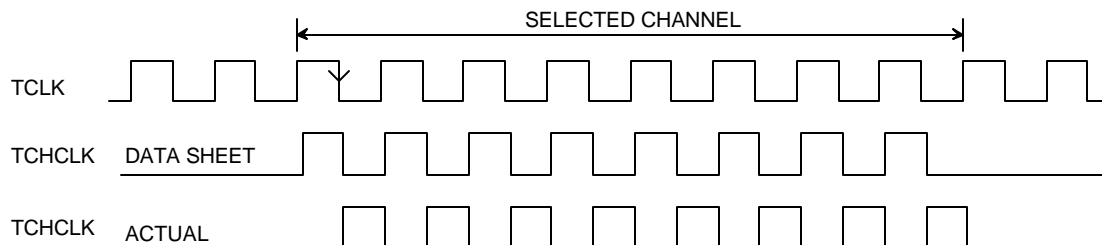
4. TRANSMIT FRACTIONAL SUPPORT

The transmit fractional support (alternate function of the TCHCLK pin) does not operate as described in the data sheet. Transmit data at the TSER pin is sampled on the falling edge of TCLK. In fractional support mode the TCHCLK pin should output a clock (gated version of TCLK) during a selected channel or channels. The rising edge of this clock could be used to present data to the TSER pin for sampling in the falling edge of TCLK. However, TCHCLK is delayed one-half clock in this rev of the DS2155. Its rising edge occurs AFTER the sampling time of the corresponding bit time of TCLK, as shown below.

There is no known software work around for this issue.

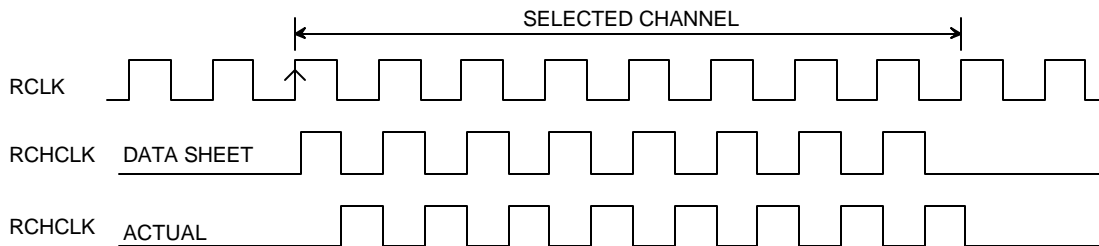
5. RECEIVE FRACTIONAL SUPPORT

The receive fractional support (alternate function of the RCHCLK pin) does not operate as described in the data sheet. Receive data at the RSER pin is updated on the rising edge of RCLK. In fractional support mode the RCHCLK pin should output a clock (gated version of RCLK) during a selected channel or channels. The falling edge of this clock could be used by the backplane to sample data output on the RSER pin. However, RCHCLK is delayed one half clock in this rev of the DS2155.

As an alternate method, the backplane can use the rising edge RCHCLK to sample data output from RSER.
